Thermal images help assessing insulation issues in curing chambers

Michael Kraft, Kraft Curing Systems GmbH, Germany

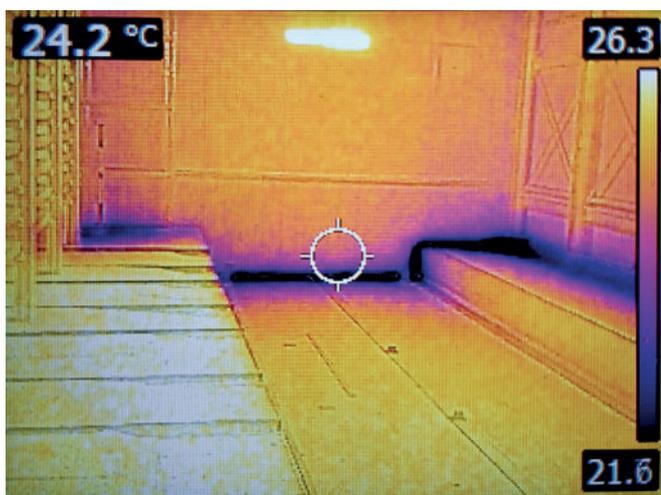
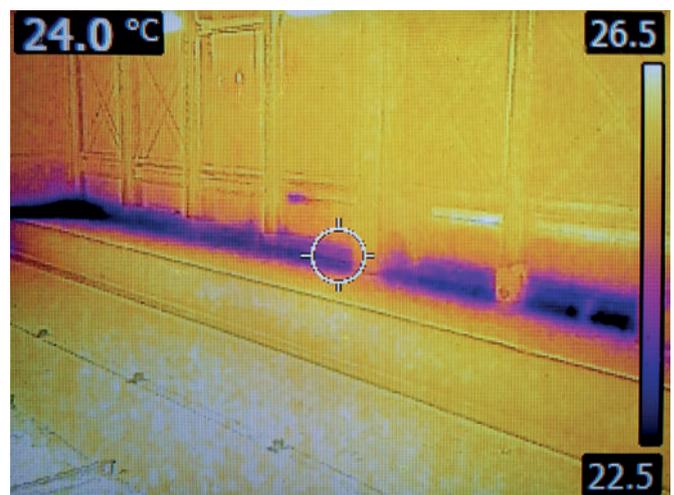
These thermal images show a well heated and circulated curing chamber - only lacking insulation of the concrete slab around the outside of the perimeter of the curing chamber. The floor in the transfer car area is bright yellow to orange, turning to darker purple as it proceeds to the exposed concrete slab. This is especially noteworthy in the recessed transfer car area. Adding insulation to this exposed slab would prevent the chance of standing water in this area.

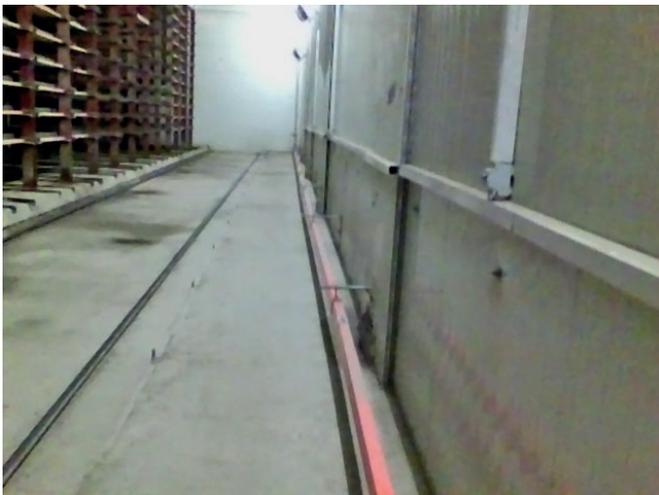
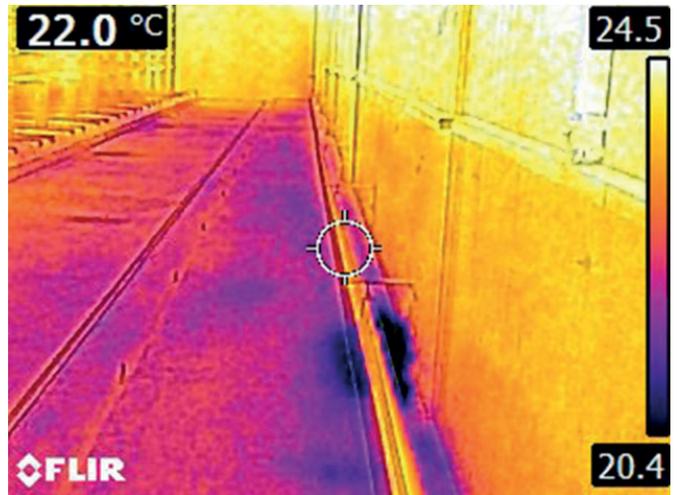
A typical transfer car area with an insulated exterior wall. Damp spots are seen throughout the area and the thermal image shows very well the coldness of the floor in the transfer car area due to poor air circulation. The dark purple spot and areas along the outside wall are indications of cold leaking into the chamber through the concrete floor.

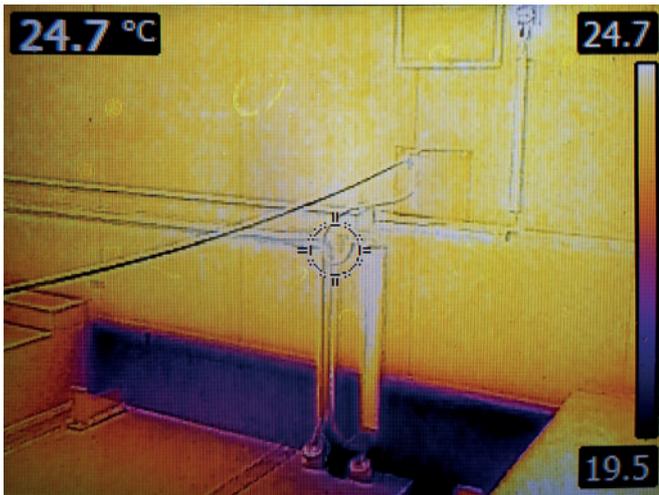
Dark purple areas at the chamber outside perimeter walls lighten slightly as the floor becomes warmer further away from the walls. The high amount of purple throughout the picture indicates poor air circulation.

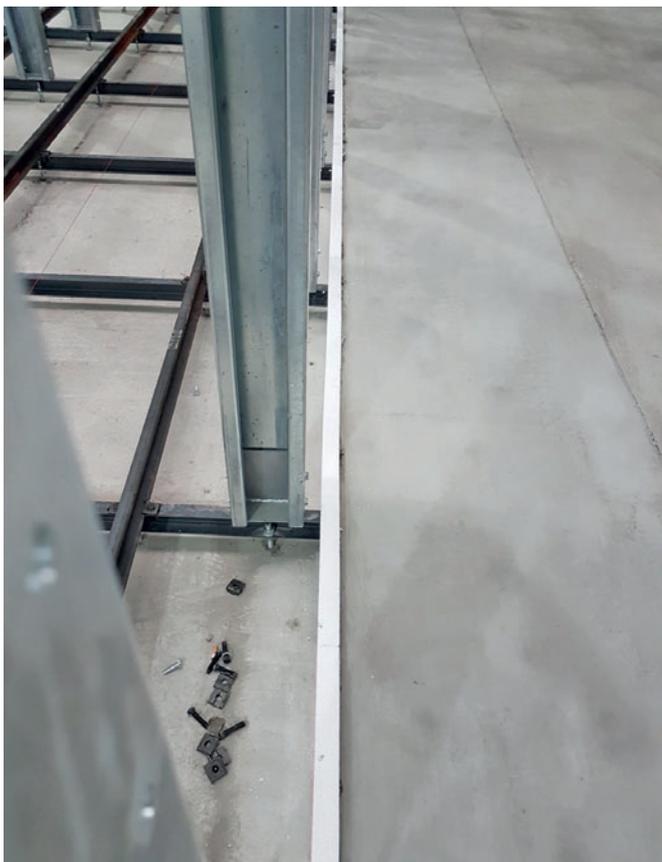
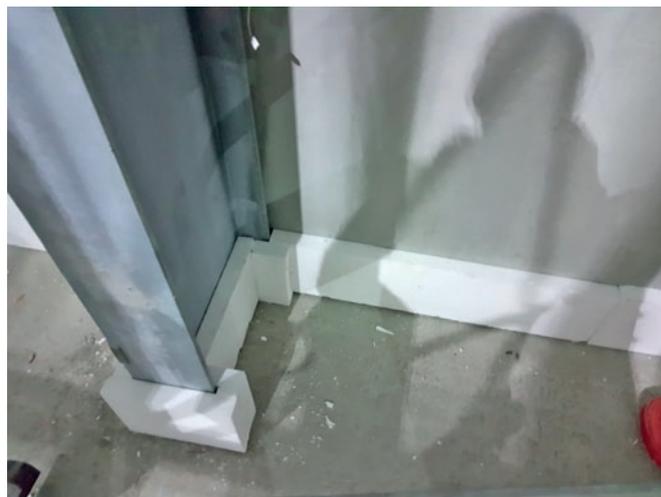
Insulation board is the solution for insulating the perimeter of the curing chamber after installing the rack and rails, but prior to placement of the screeded floor. All steel support beams for the production building must be insulated and isolated from the concrete inside the curing chamber. These steel columns are highly efficient thermal bridges and can cause numerous issues in the way of standing water.

Eliminating the thermal bridge is easiest to do when the curing chamber is in the design and build phase. The use of 40 mm to 80 mm insulation board is inexpensive and installed quickly as a thermal break in the concrete floor or curb around the perimeter of the chamber. This thermal break is as effective as the insulation panel walls at preventing condensation and will, as part of a complete professional solution of air circulation, heating and moisturizing, provide relief from standing water.

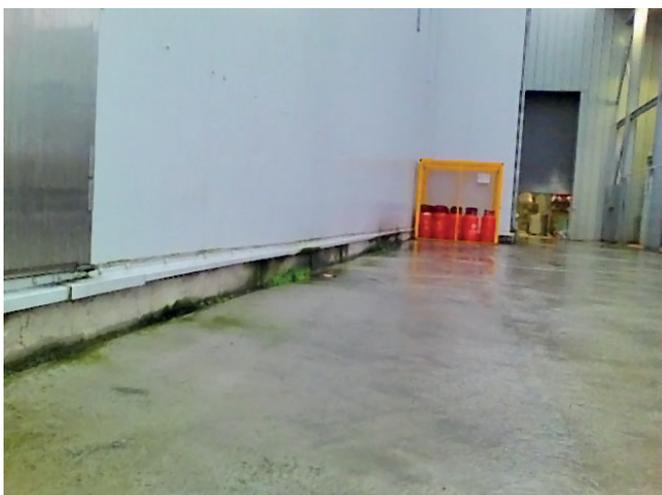
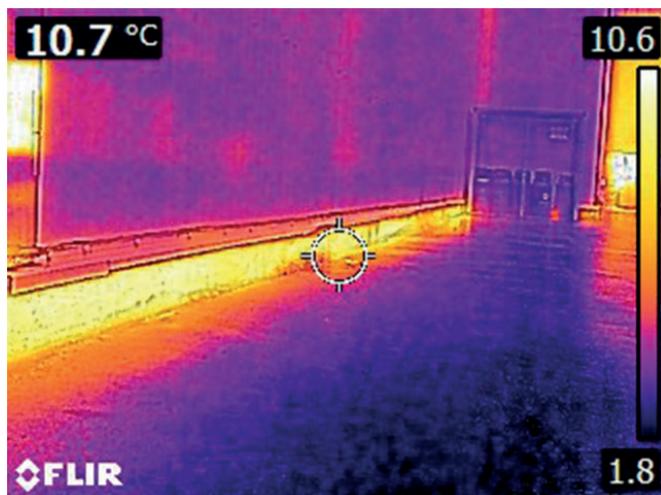
Thermal bridges are also a cause for high energy consumption. These pair of photographs shows very clearly the heat loss from through the raised concrete slab of the curing chamber. With an outside temperature equal to 2°C, this slab is radiating 10°C heat to the atmosphere. Insulating this slab would not only prevent standing water in the curing area, but also reduce energy costs.
